Manhole Inspection Summary

Manhole # **S27CC_009MH**

Insp Date: **11/9/07 12:04 PM**

Location Address: **517 LAFAYETTE**

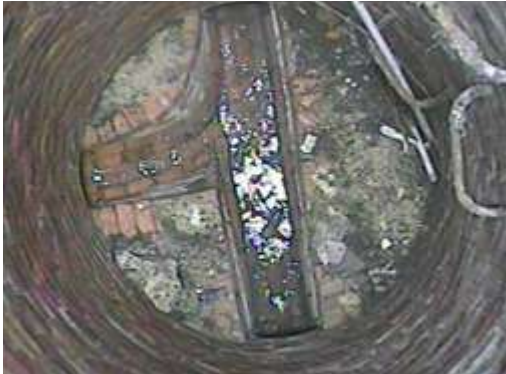
Defect 1

Count: **6** Missing: **0** ☒ **Corroded**

STEPS CORRODED

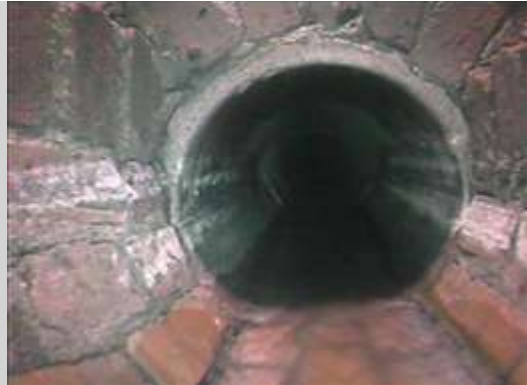
12 O'Clock Outflow

10 in. Circular Gravity Sewer
Pipe Out @ 12 O'Clock

Pipe Material: **Clay** ☐ Pipe Lined

Invert Depth: **10.48** (ft.) Flow Characteristics: **Slow**

Infiltration: **None** Pipe Seal Cond: **Sound**

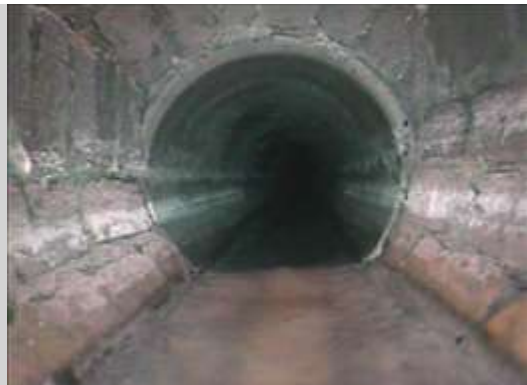
6 O'Clock Inflow

10 in. Circular Gravity Sewer
Pipe In @ 6 O'Clock

Pipe Material: **Clay** ☐ Pipe Lined

Invert Depth: **10.42** (ft.) Flow Characteristics: **Slow**

Infiltration: **None** Pipe Seal Cond: **Sound**

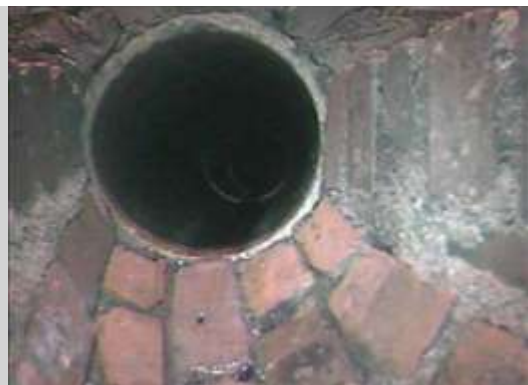
9 O'Clock Inflow

8 in. Circular Gravity Sewer
Pipe In @ 9 O'Clock

Pipe Material: **Clay** ☐ Pipe Lined

Invert Depth: **10.10** (ft.) Flow Characteristics: **Slow**

Infiltration: **None** Pipe Seal Cond: **Sound**
